FINAL REPORT *OF* A BOARD OF INVESTIGATION

*To Inquire Into*  
THE DESIGN  
AND METHODS OF CONSTRUCTION  
OF WELDED STEEL MERCHANT  
VESSELS

15 JULY 1946

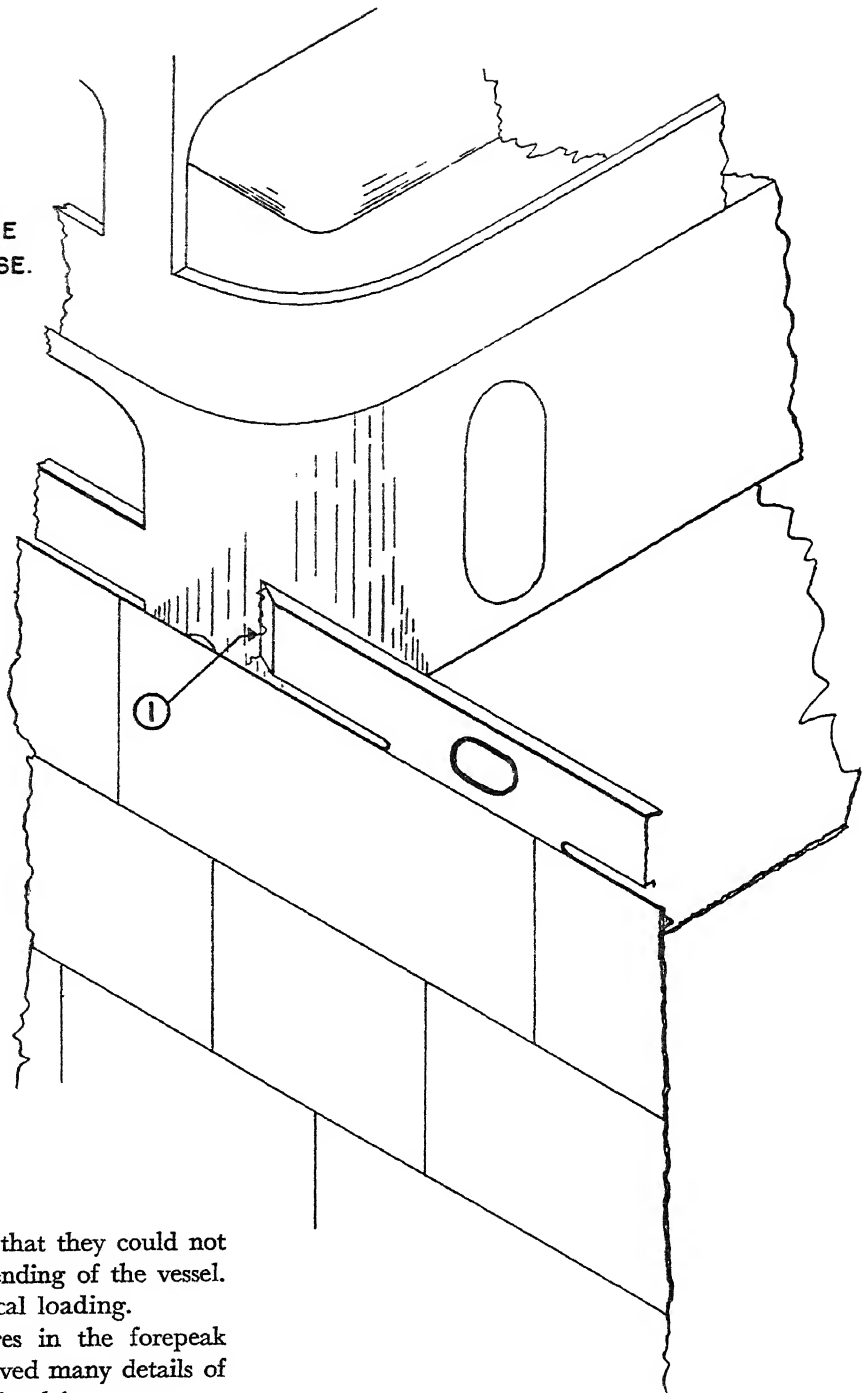
Figure 41.

VICTORY SHIP  
TYPICAL BULWARK FRACTURE  
AT FWD. END OF DECK HOUSE.

- ① LEWISTON VICTORY  
23, JAN. 1946  
FWD. END P. & S.  
AFT END P. & S.
- ② GRINNELL VICTORY  
BEFORE AUG. 1945  
FWD. END, PORT ONLY  
AFT END P. & S.

Most of the bulwark failures occur at the forward and aft end of the deck house where the bulwark is flanged to land perpendicular to the rounded house front, figure 41. This is a poor design detail but is not a dangerous feature because experience with the Liberties led to constructing the Victory bulwarks free of the top of the sheer strake. This freedom prevents the cracks from propagating into the hull.

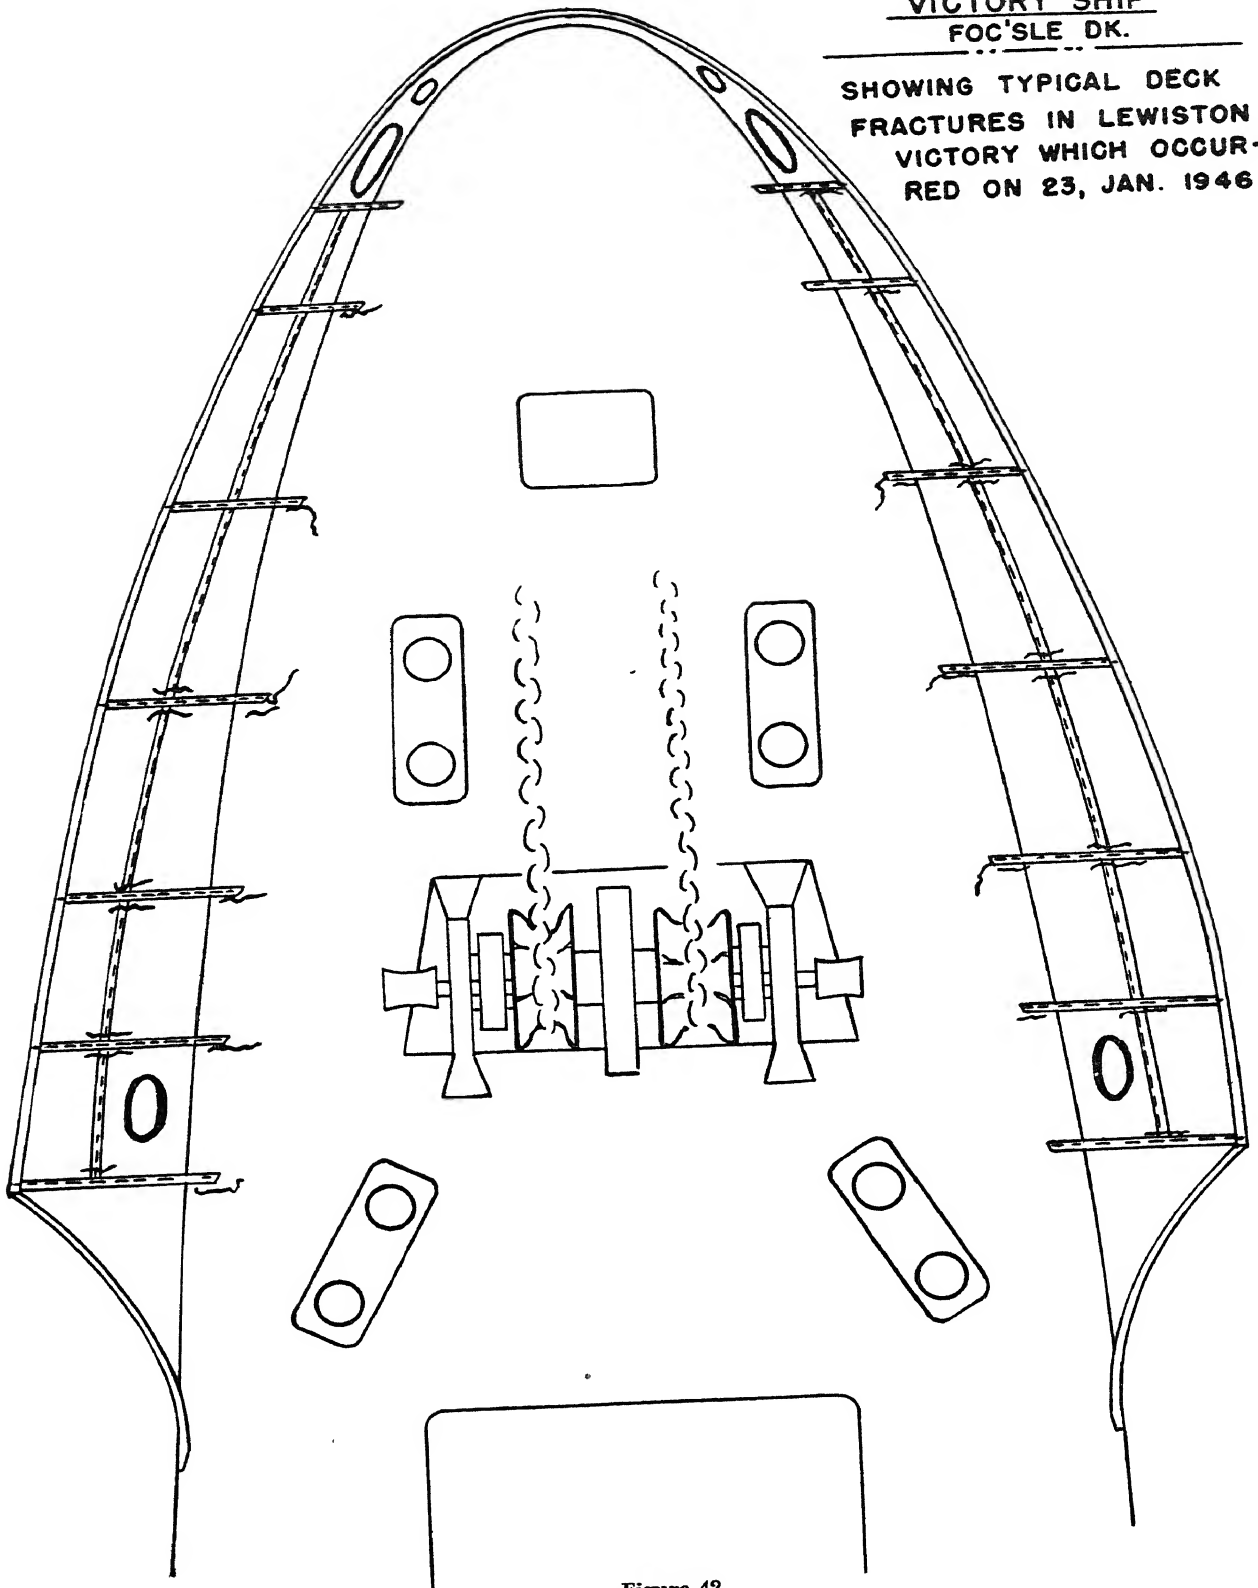
Figure 42.

SHOWING TYPICAL DECK  
FRACTURES IN LEWISTON  
VICTORY WHICH OCCUR-  
RED ON 23, JAN. 1946

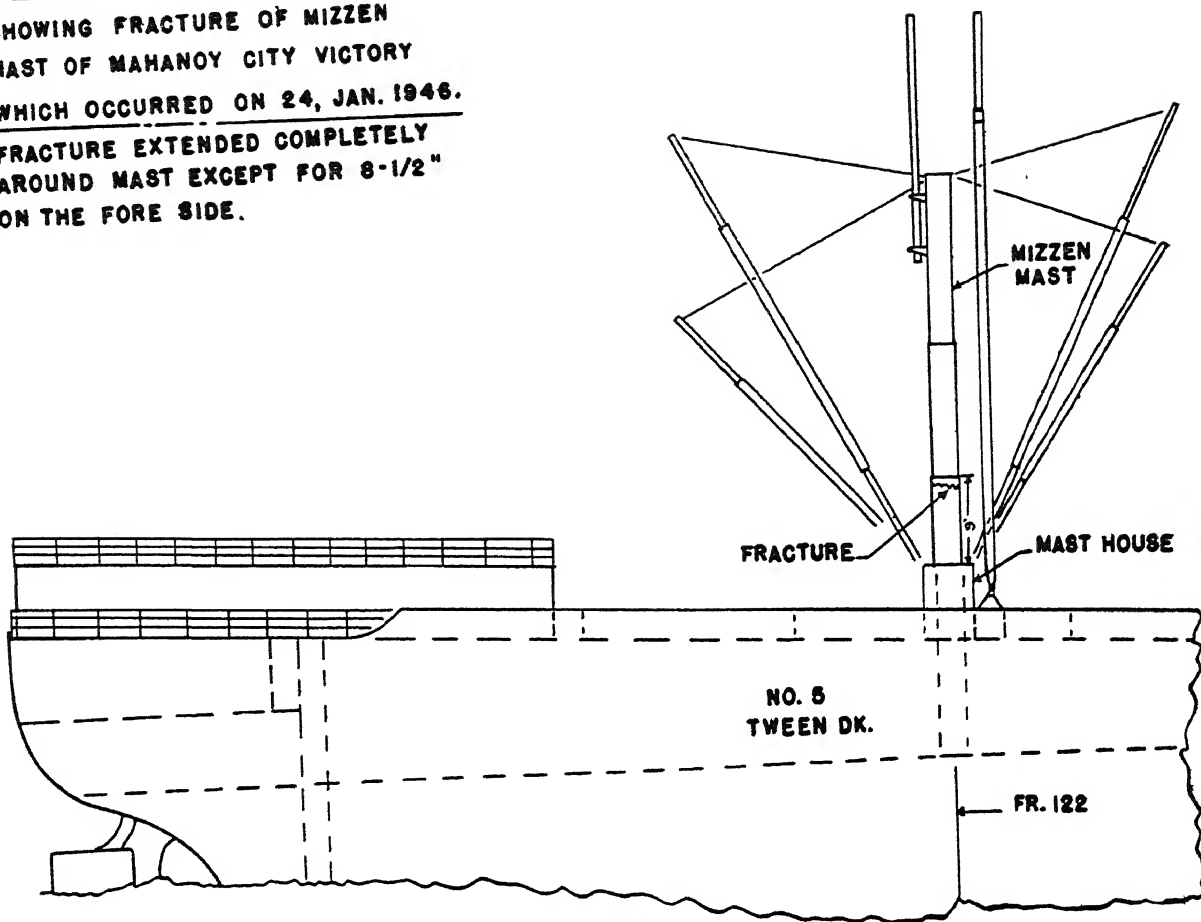
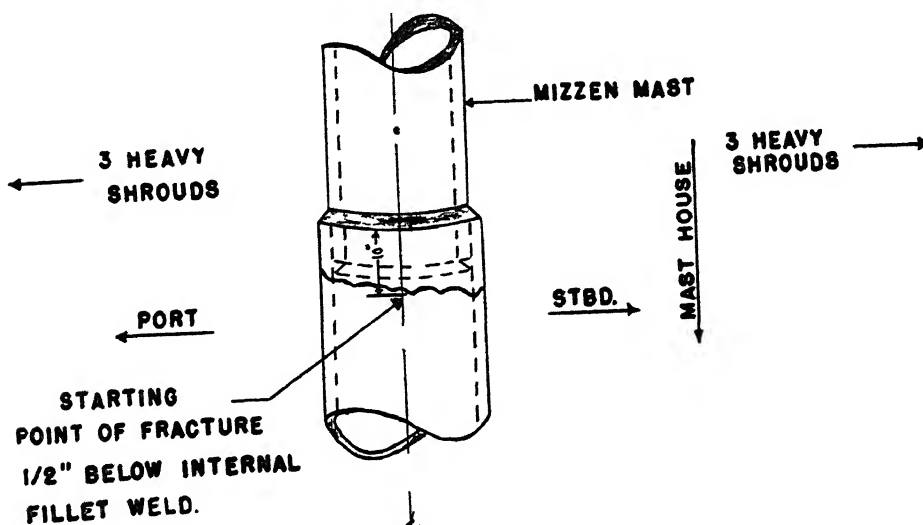
Figure 43.

SHOWING FRACTURE OF MIZZEN  
MAST OF MAHANAOY CITY VICTORY  
WHICH OCCURRED ON 24, JAN. 1946.

FRACTURE EXTENDED COMPLETELY  
AROUND MAST EXCEPT FOR 8-1/2"  
ON THE FORE SIDE.

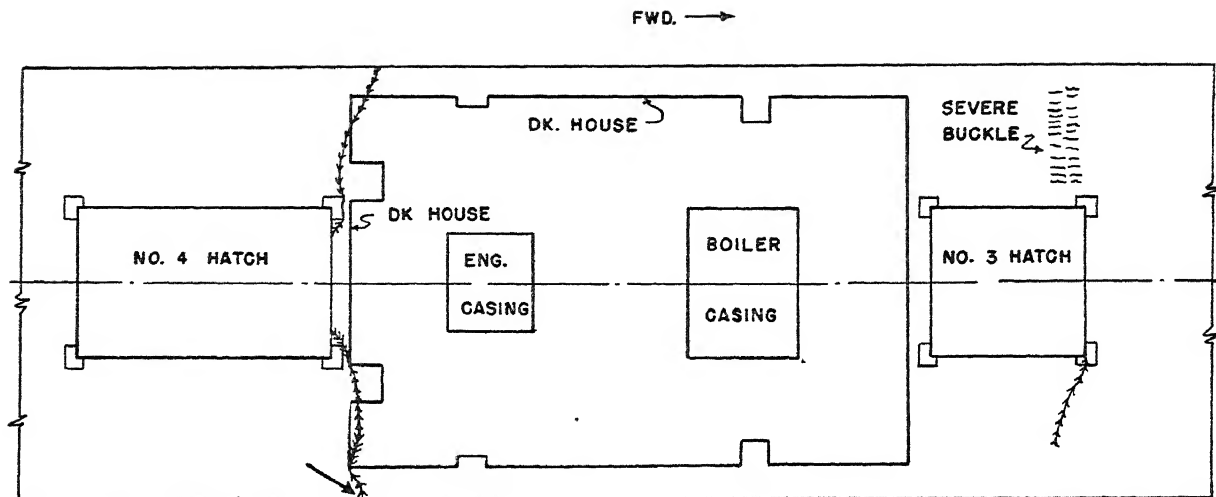
Figures 53, 54 and 55 describe a typical case of an effective crack arrestor. The photographs were taken

PLAN VIEW OF UPPER DECK.

S.S. COLIN P. KELLY JR.

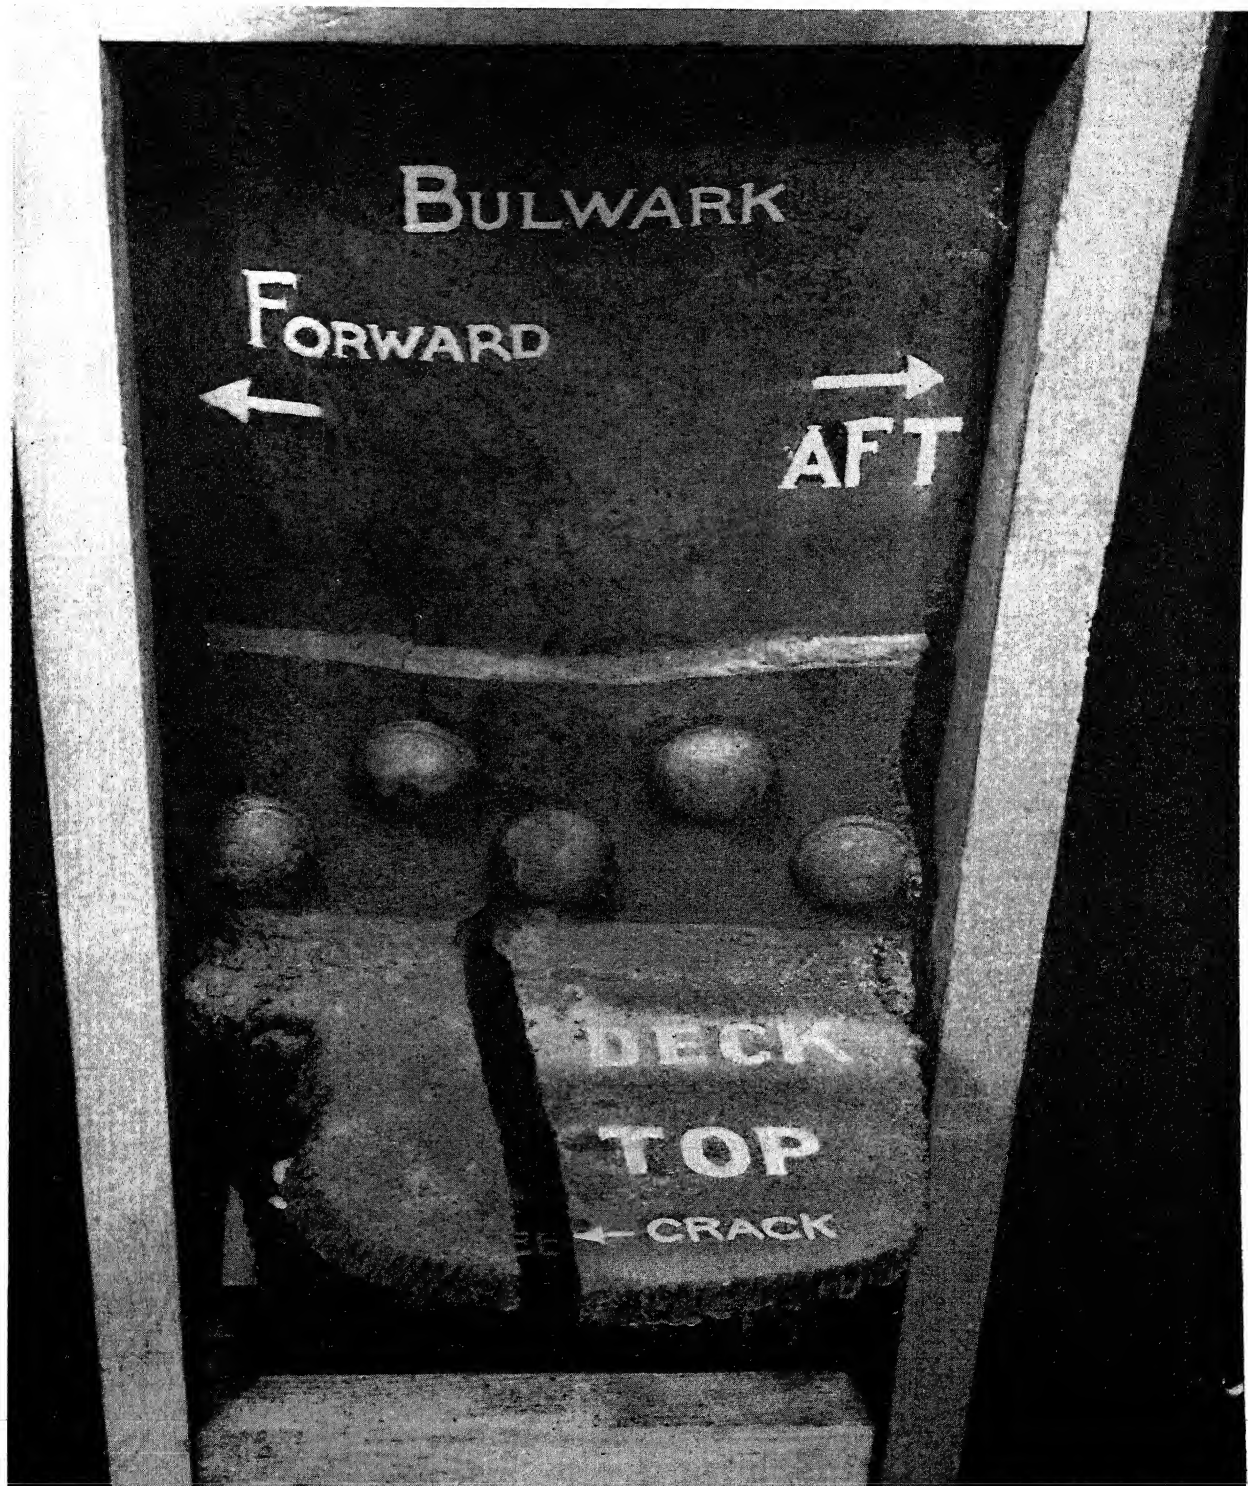
FIGURE 54.—Termination of fracture at gunwale, starboard side, *S. S. Colin P. Kelly Jr.* (see arrow fig. 53.)

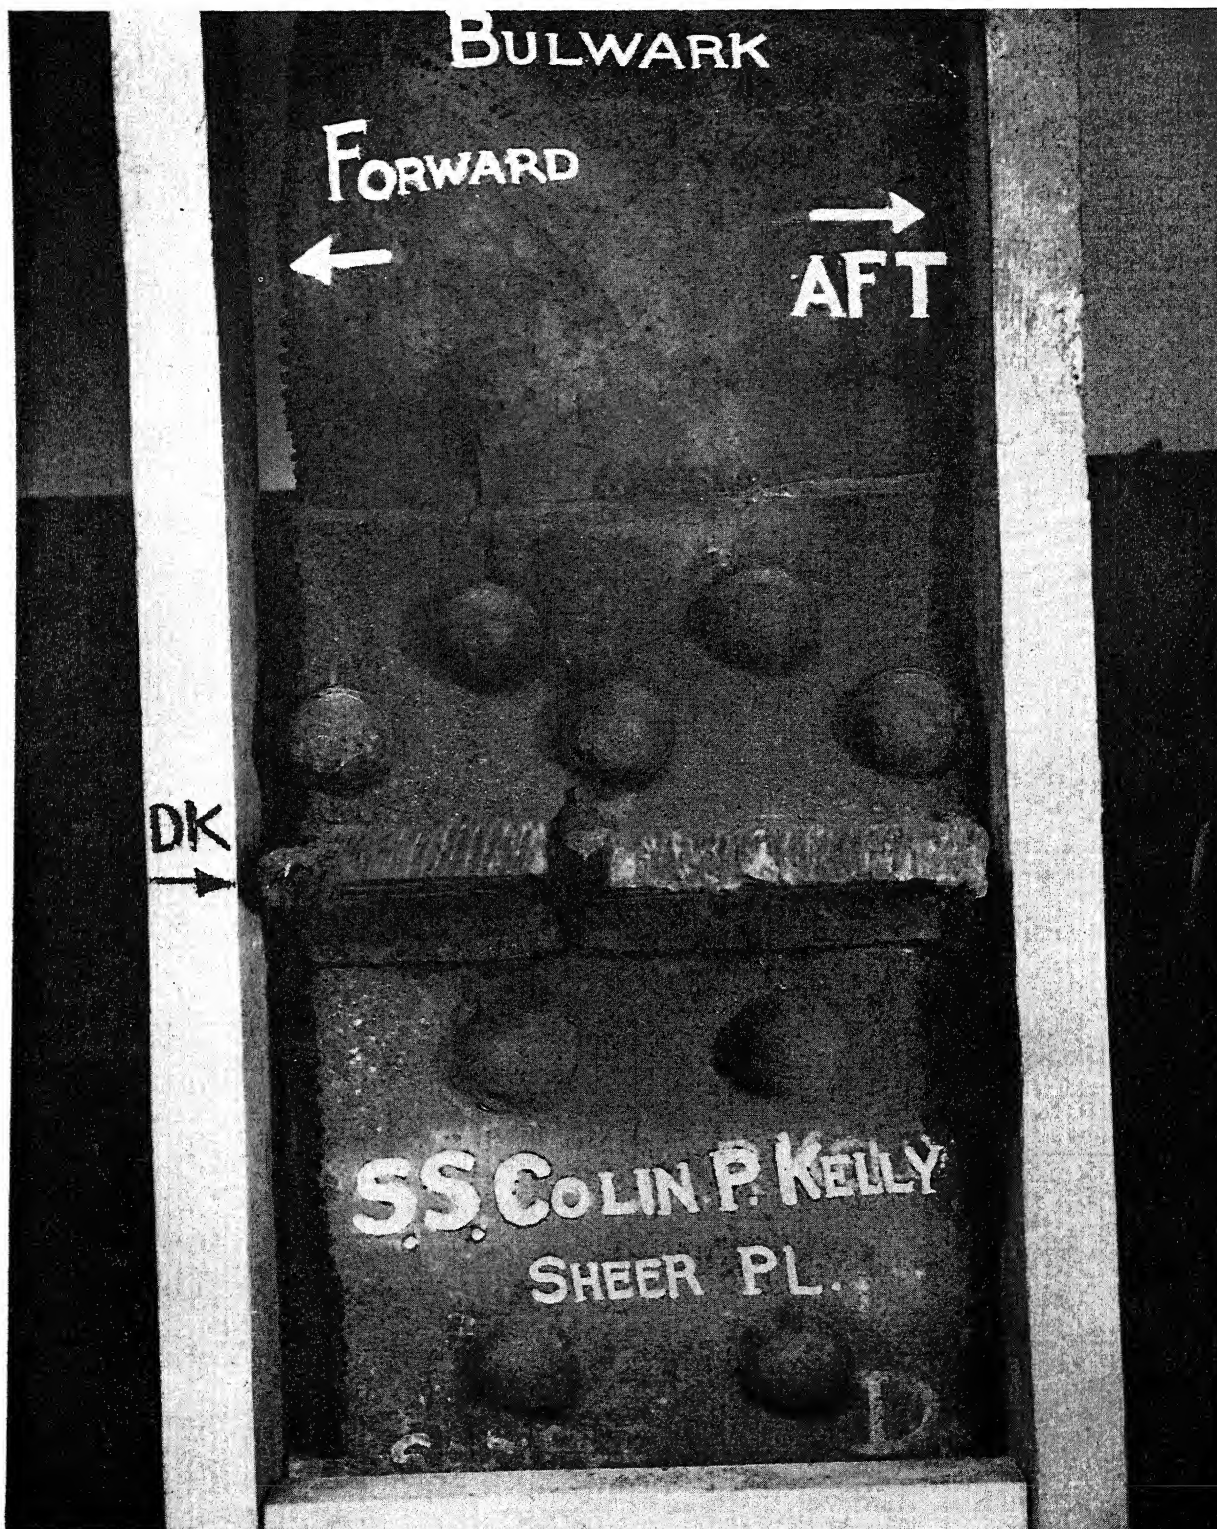
FIGURE 55.—Termination of fracture at gunwale, starboard side, *S. S. Colin P. Kelly Jr.* (Note horizontal torch cut below deck, see fig. 52.)

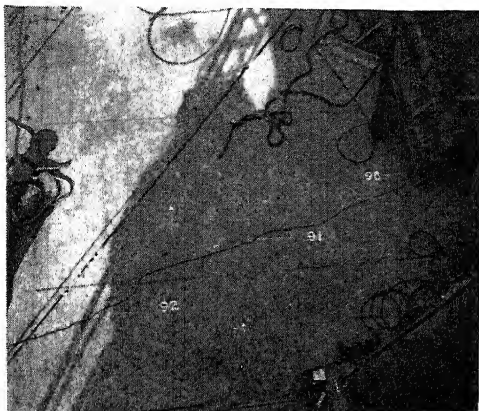
FIGURE 1

WEATHER DECK OF S.S. SEA BASS AS VIEWED FROM ABOVE SHOWING FRACTURE FROM THE AFTER PORT CORNER OF NO. 3 HATCH.

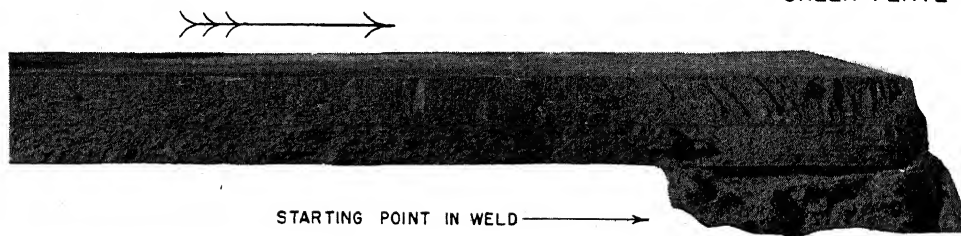
FIGURE 3

FRACTURED 51\* DECK PLATE FROM FIGURE 2 SHOWING POORLY FUSED WELD IN UPPER FLANGE OF LONGITUDINAL HATCH SIDE GIRDER.

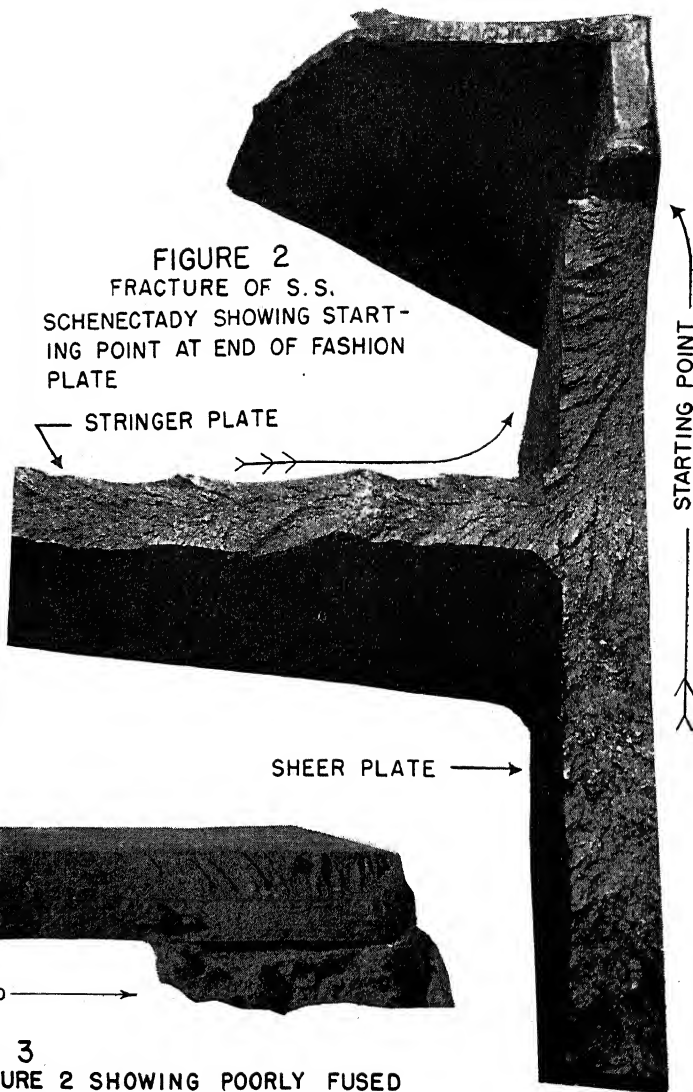
FIGURE 2

FRACTURE OF S.S. SCHENECTADY SHOWING STARTING POINT AT END OF FASHION PLATE
